# IN-SERVICE PERFORMANCE AND COSTS OF METHODS TO CONTROL URBAN RAIL SYSTEM NOISE

## SECOND TEST SERIES REPORT

INTERIM REPORT

U.S. DEPARTMENT OF TRANSPORTATION  
URBAN MASS TRANSPORTATION ADMINISTRATION  
Office of Technology Development and Deployment  
Office of Rail and Construction Technology  
Washington DC 20590

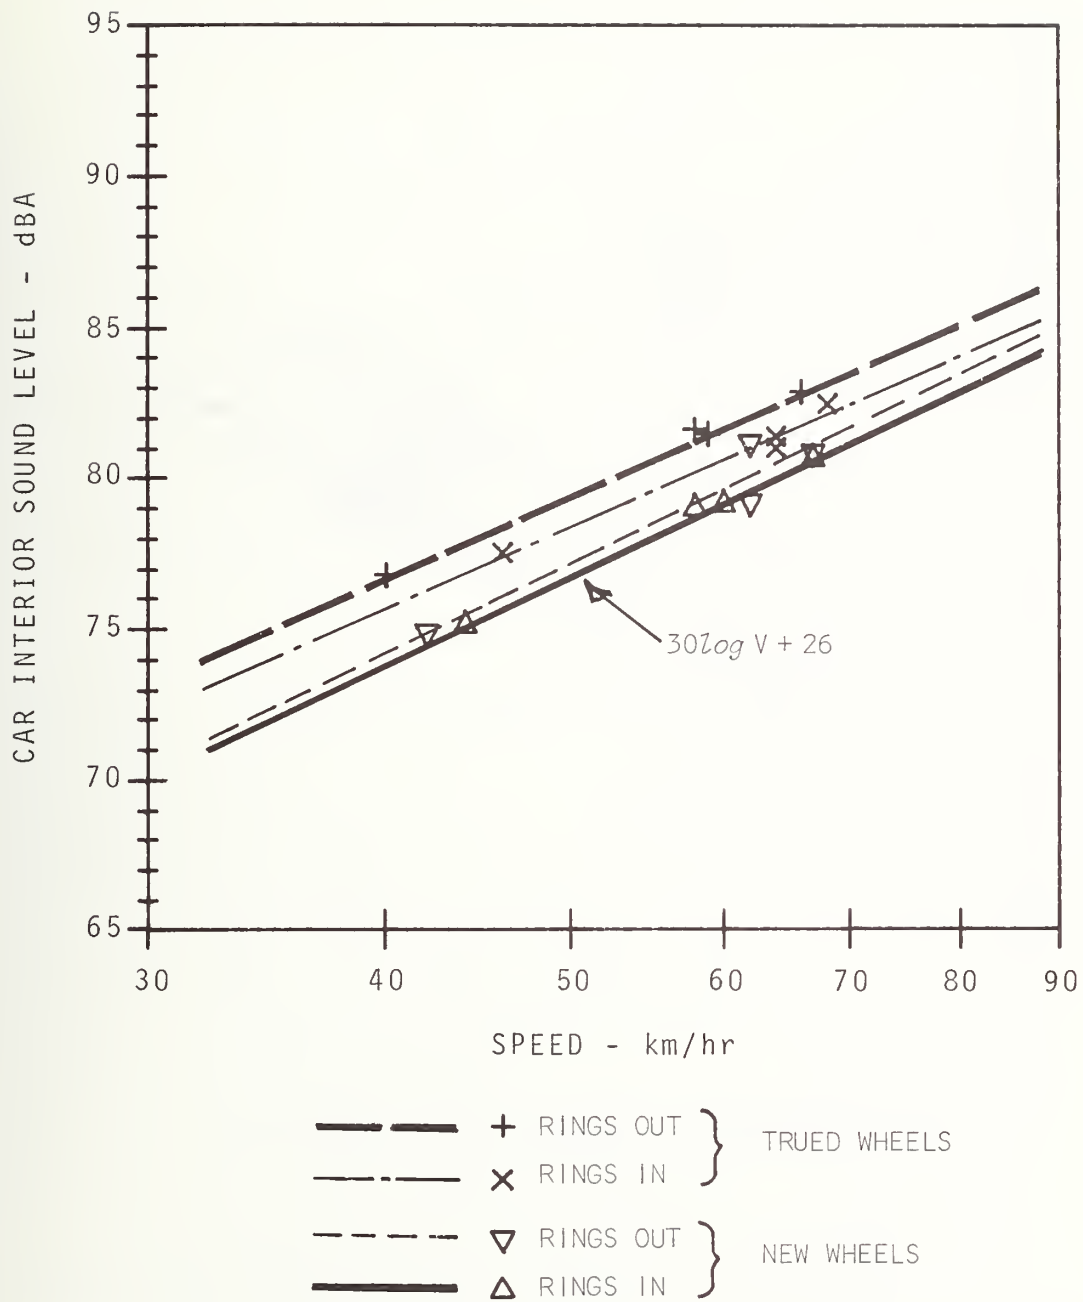
FIGURE 4-7. CAR INTERIOR SOUND LEVELS WITH AND WITHOUT RING DAMPERS, GROUND TANGENT WELDED TRACK, NEW AND TRUED GROOVED WHEELS

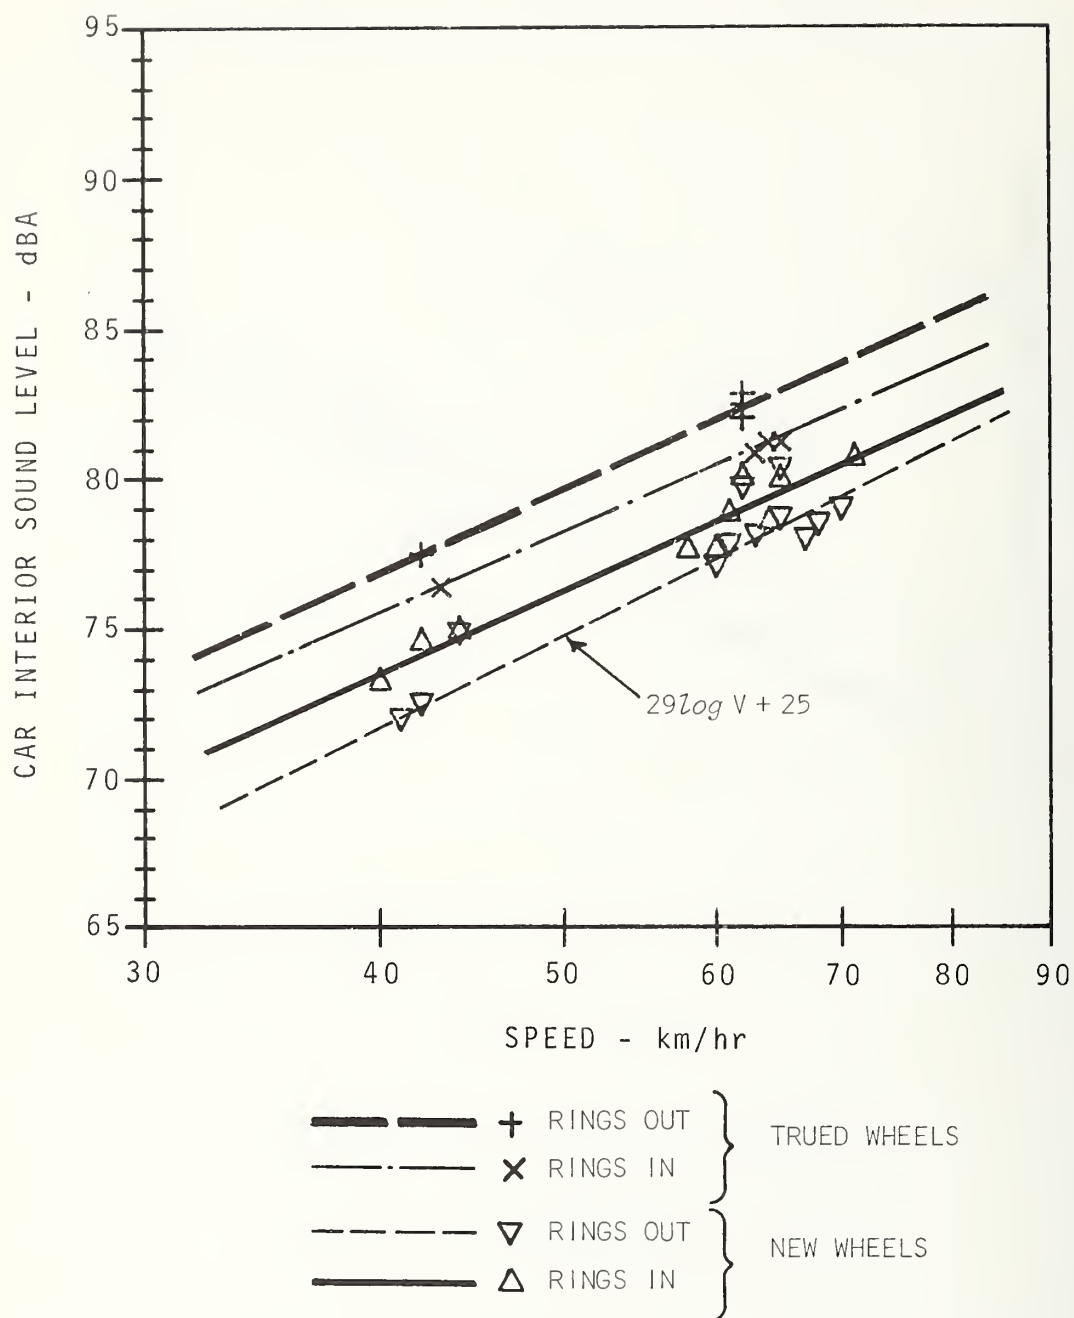
FIGURE 4-8. CAR INTERIOR SOUND LEVELS WITH AND WITHOUT RING DAMPERS, WORN TANGENT WELDED TRACK, NEW AND TRUED GROOVED WHEELS

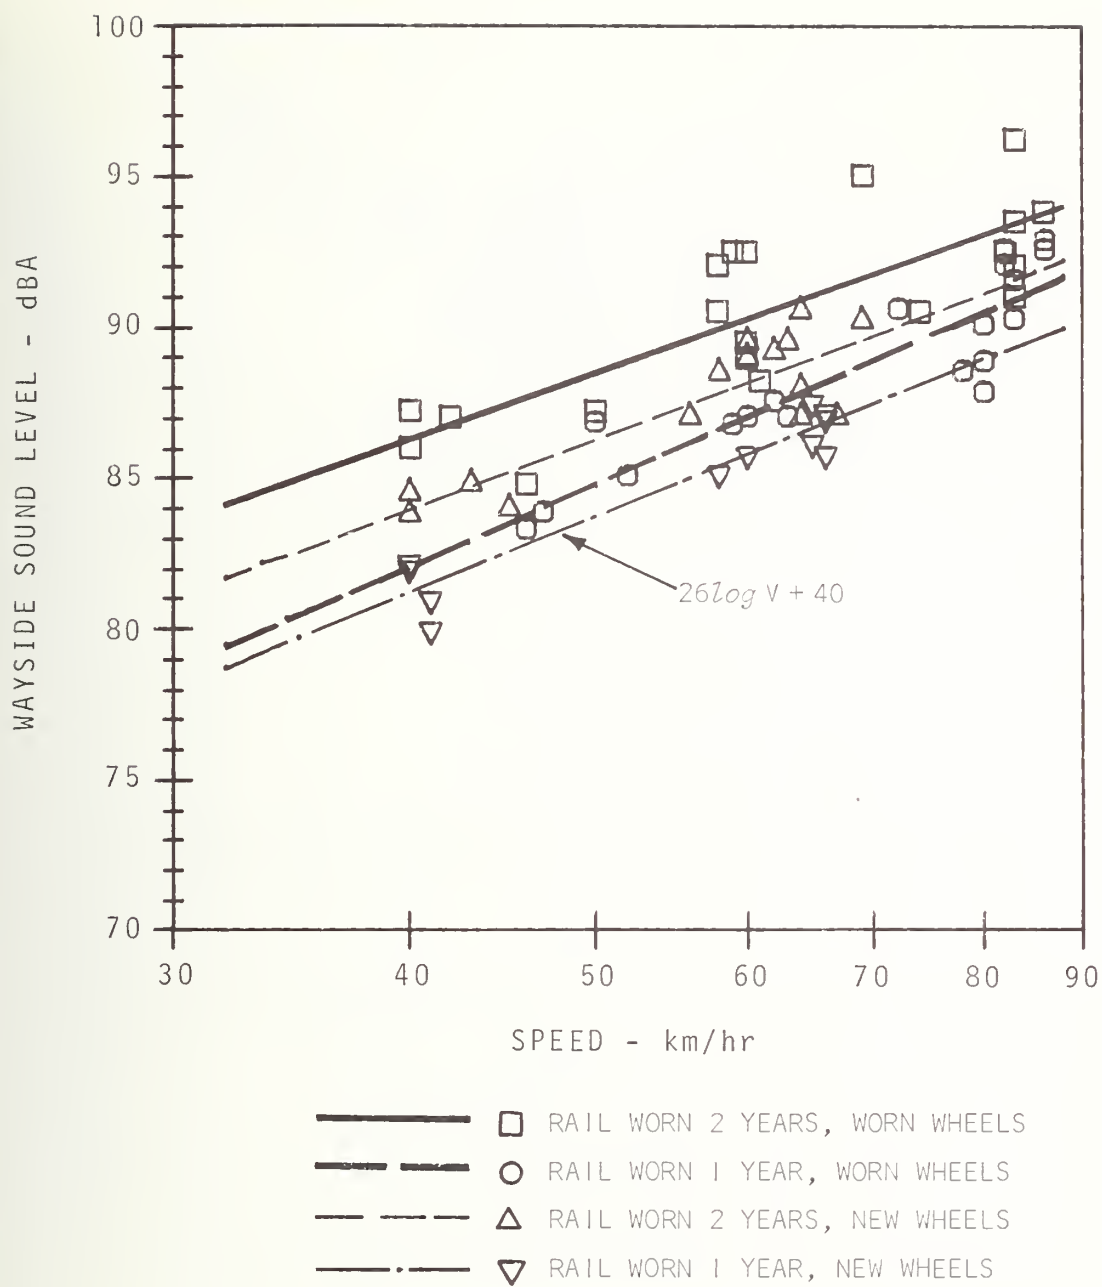
FIGURE 4-9. WAYSIDE SOUND LEVELS AT THE TANGENT JOINTED TEST TRACK WITH NEW AND WORN WHEELS AND WITH RAILS WORN 1 AND 2 YEARS  
7.5 m FROM TRACK CENTERLINE

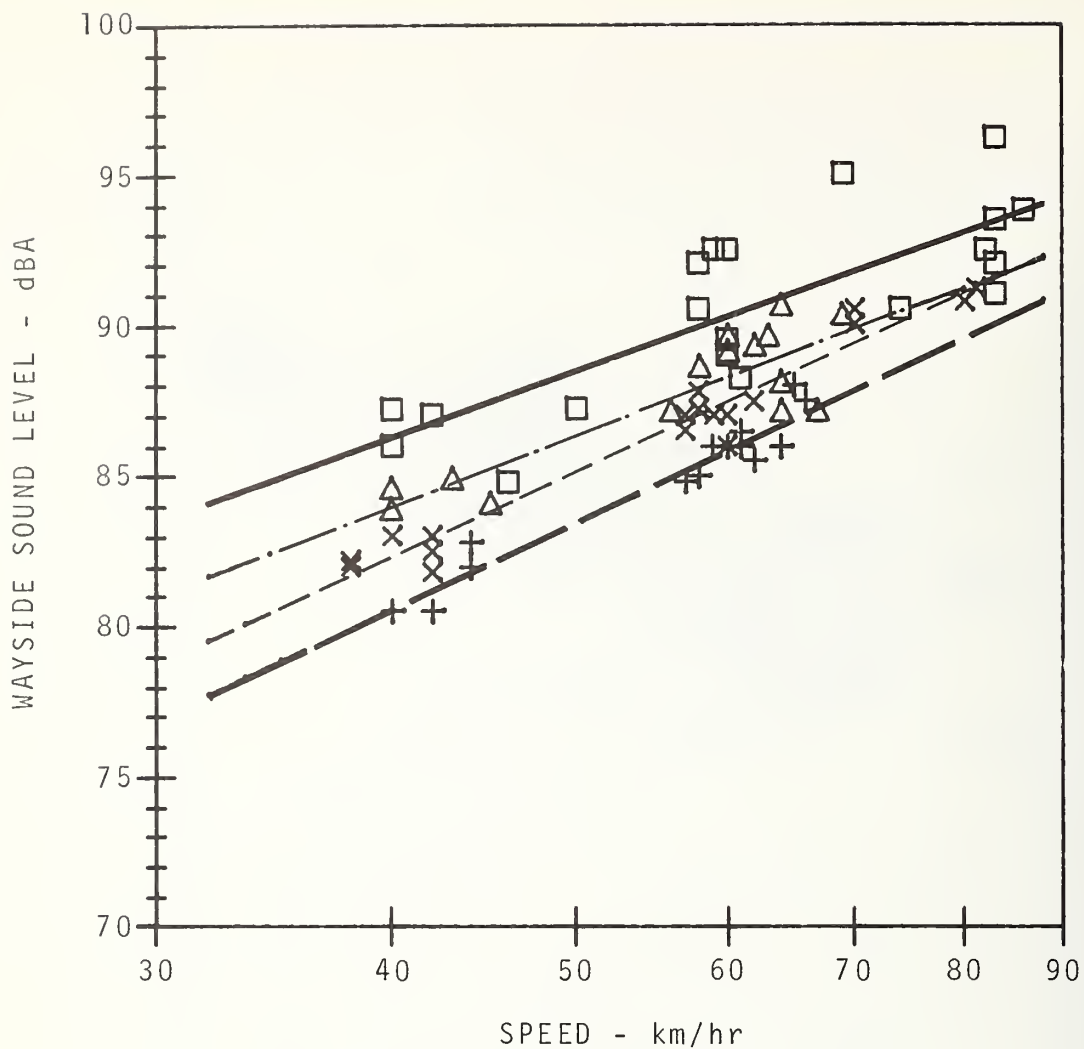
FIGURE 4-10. WAYSIDE SOUND LEVELS AT TANGENT JOINTED TEST TRACK WITH NEW AND WORN WHEELS AND WITH RAILS GROUND AND WORN TWO YEARS

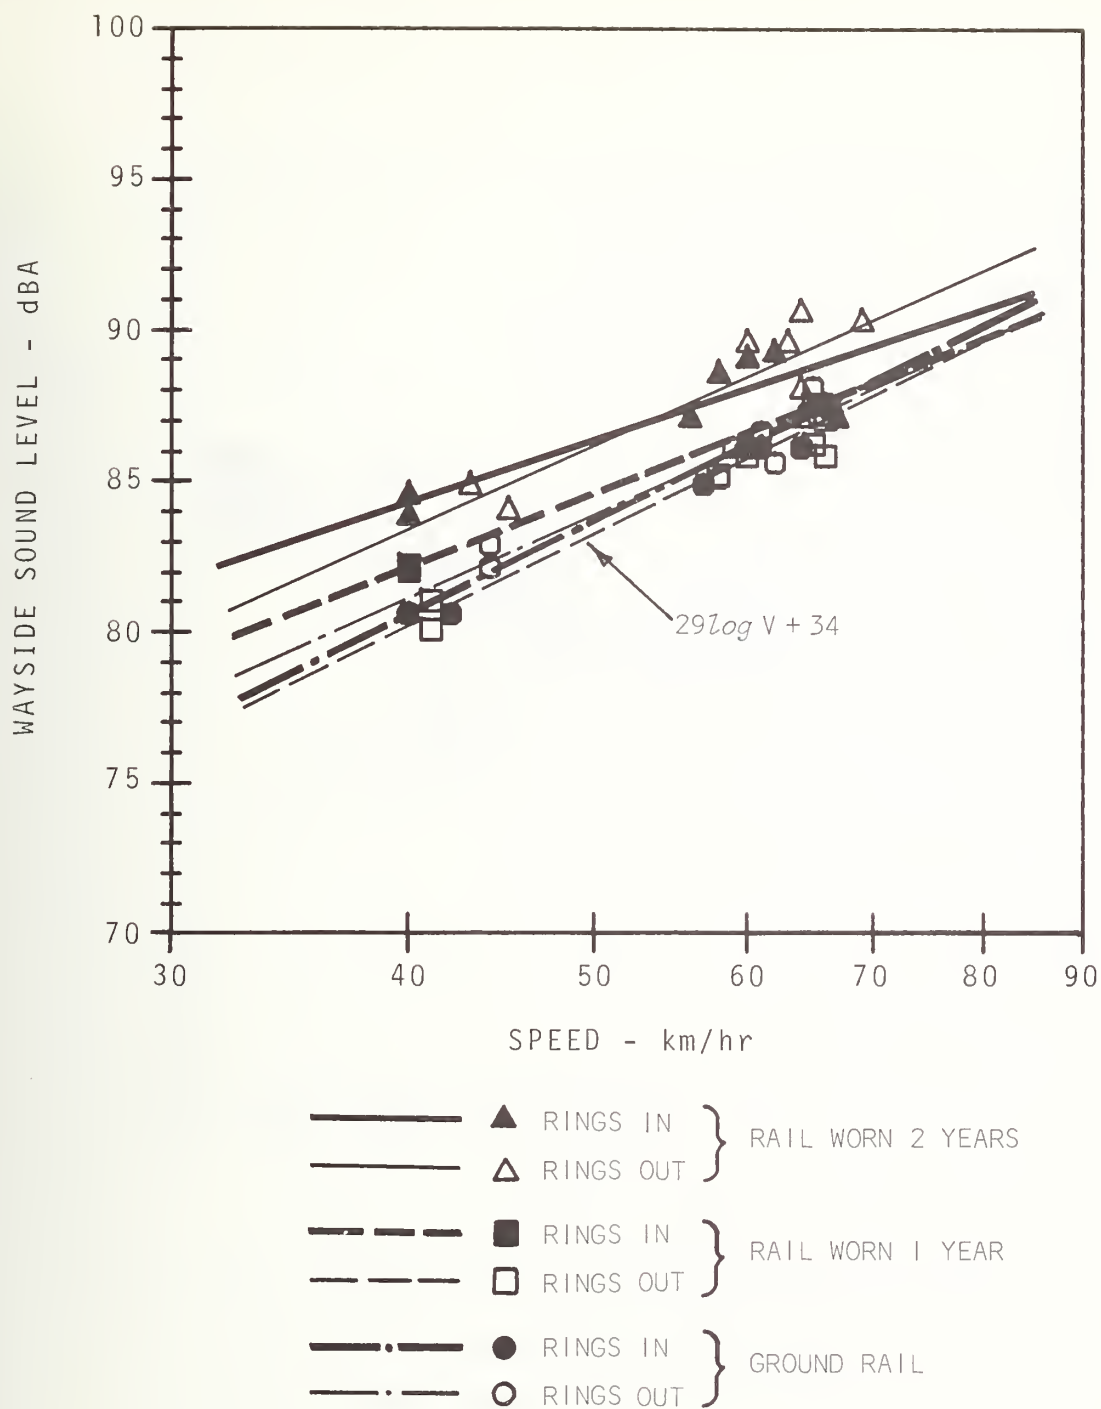
FIGURE 4-11. WAYSIDE SOUND LEVELS WITH NEW GROOVED WHEELS WITH AND WITHOUT RING DAMPERS, TANGENT JOINTED TEST TRACK

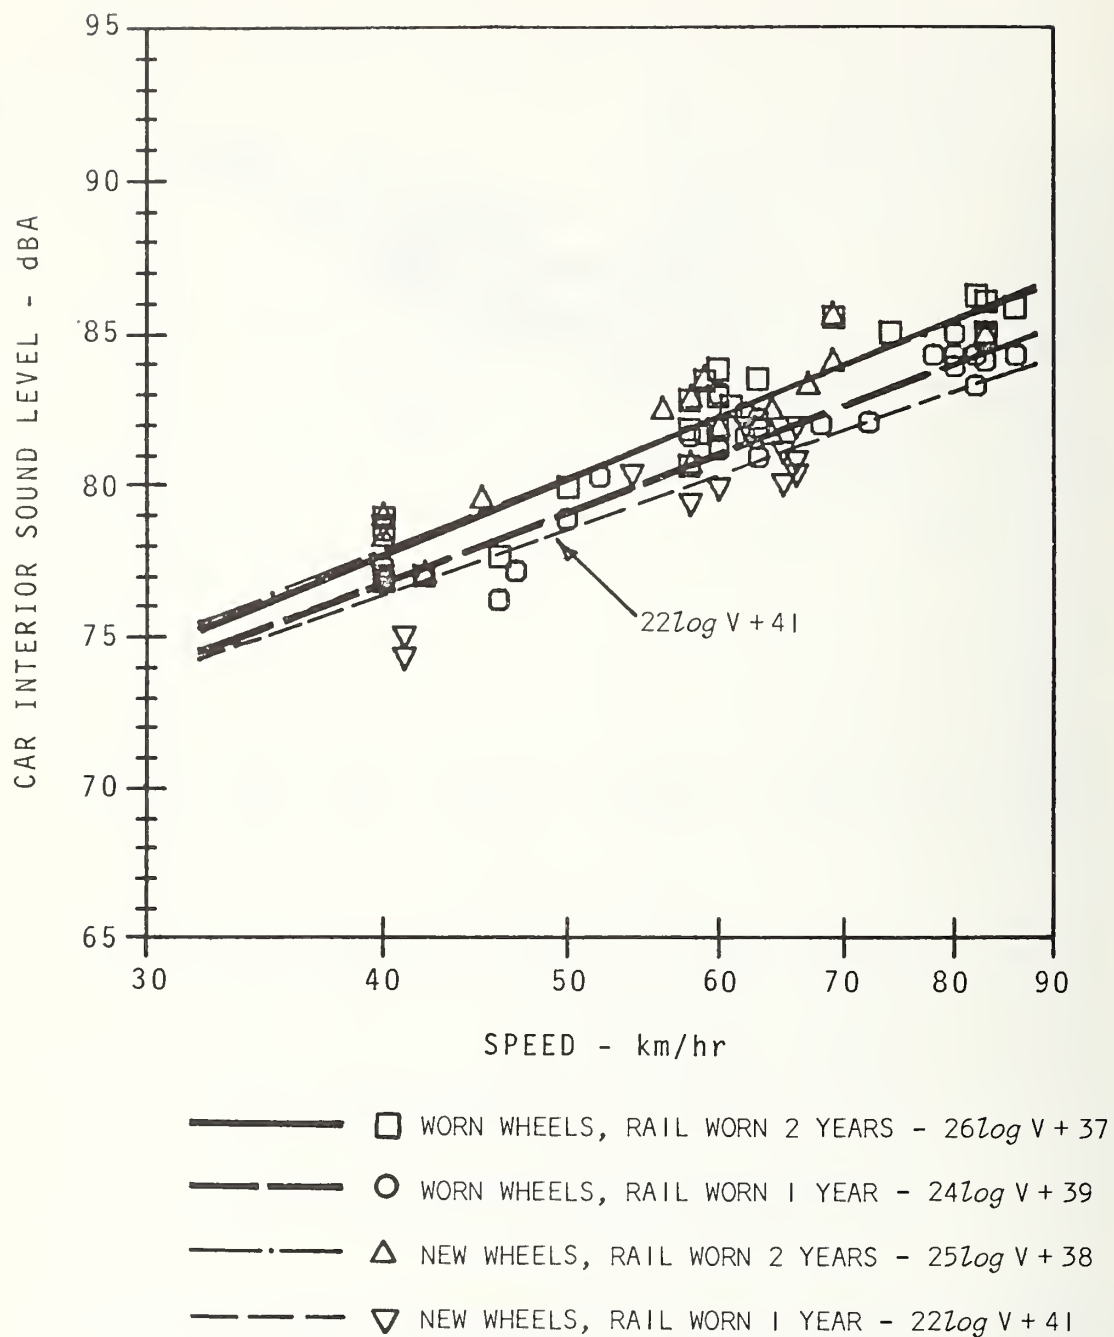
FIGURE 4-12. CAR INTERIOR SOUND LEVELS ON THE TANGENT JOINTED TEST TRACK WITH NEW AND WORN WHEELS AND WITH RAILS WORN 1 AND 2 YEARS - TEST SERIES 2

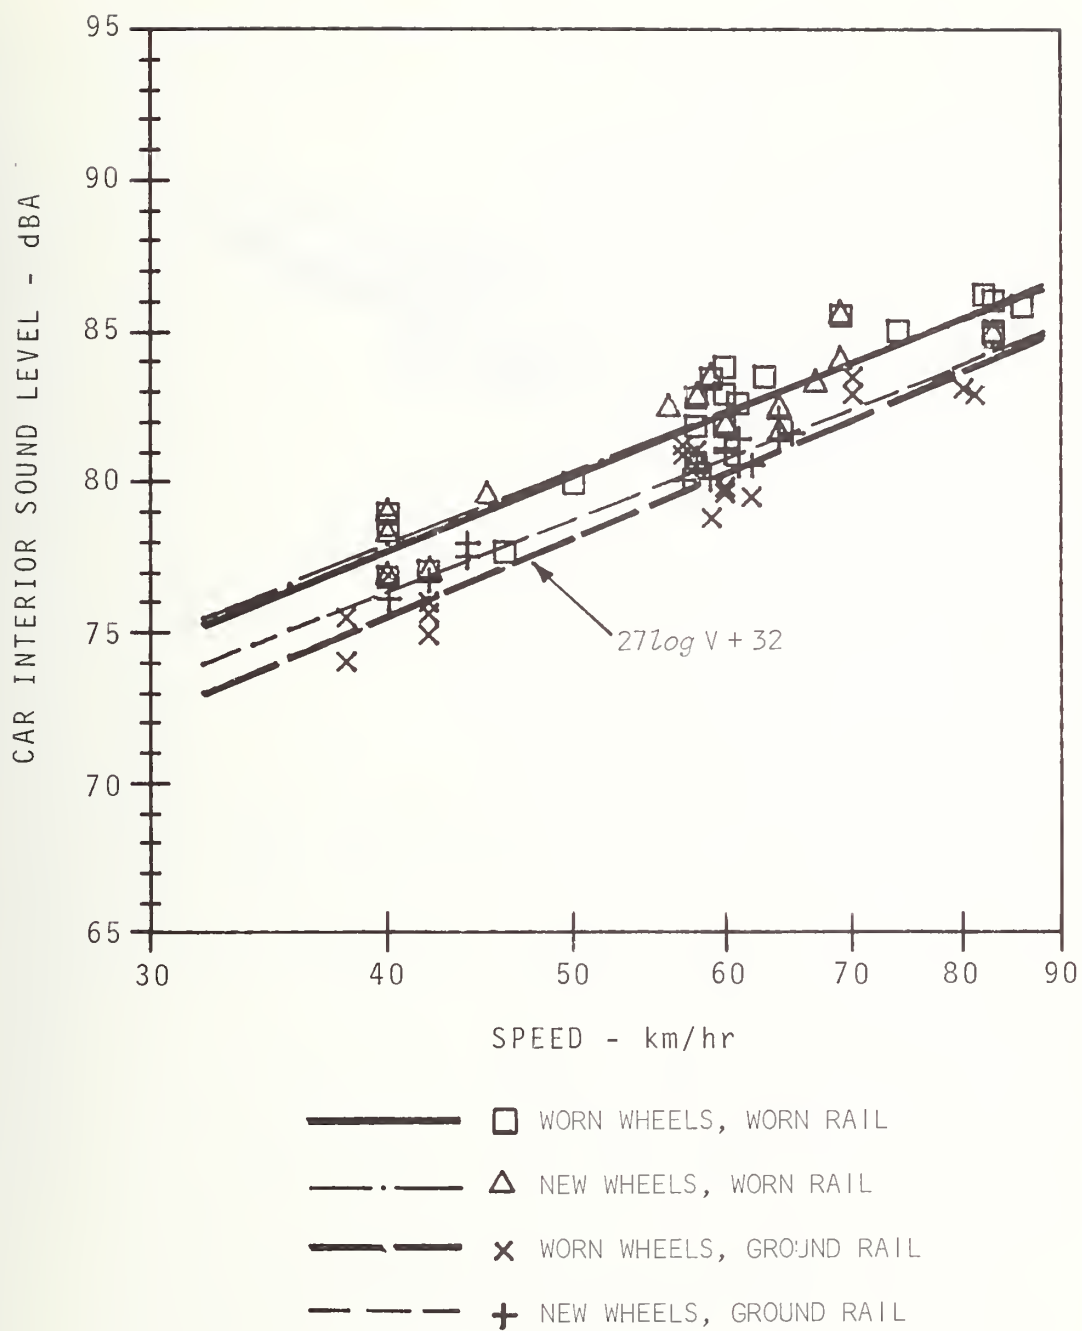
FIGURE 4-13. CAR INTERIOR SOUND LEVELS ON TANGENT JOINTED TEST TRACK WITH NEW AND WORN WHEELS AND WITH RAILS GROUND AND WORN 2 YEARS

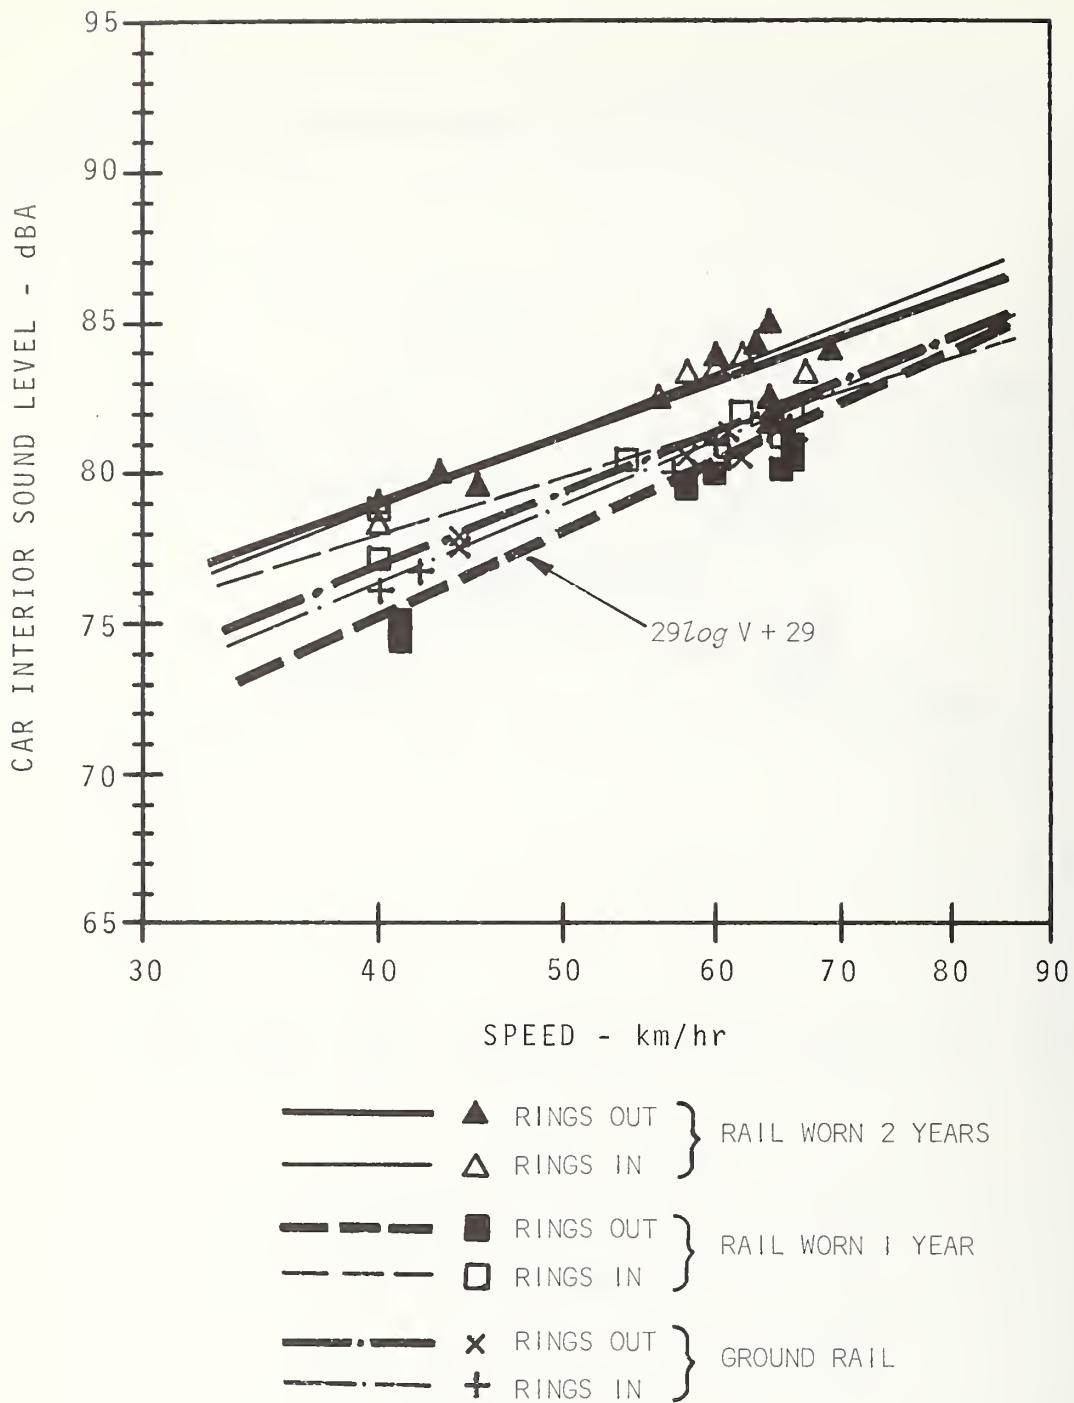
FIGURE 4-14. CAR INTERIOR SOUND LEVELS WITH NEW GROOVED WHEELS WITH AND WITHOUT RING DAMPERS, TANGENT JOINTED TEST TRACK

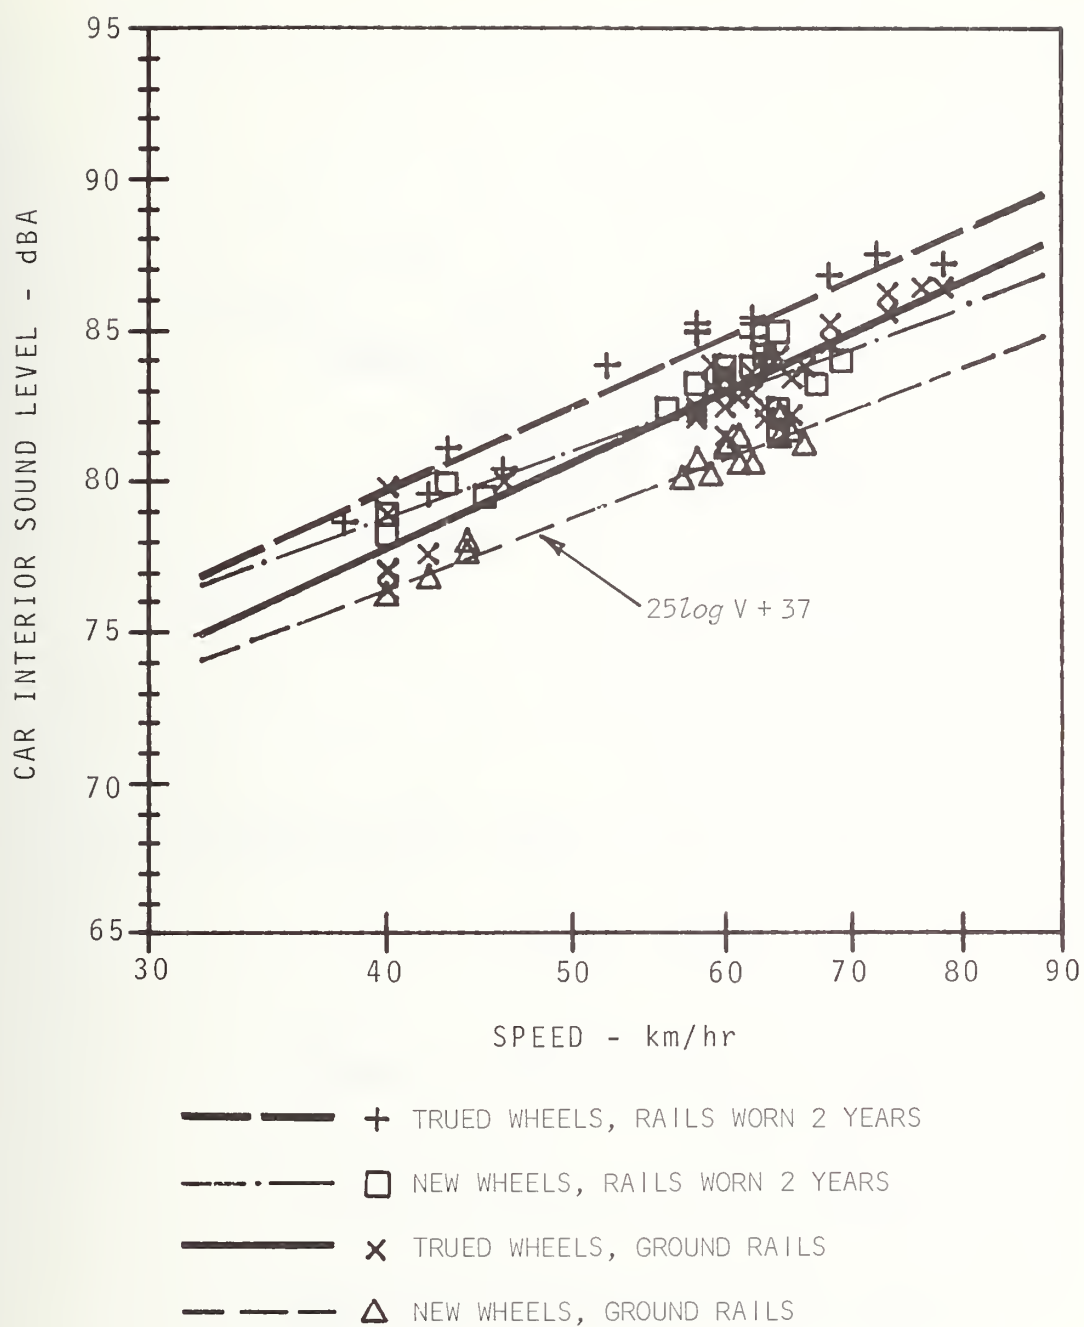
FIGURE 4-15. CAR INTERIOR SOUND LEVELS WITH NEW AND TRUED WHEELS ON THE TANGENT JOINTED TEST TRACK

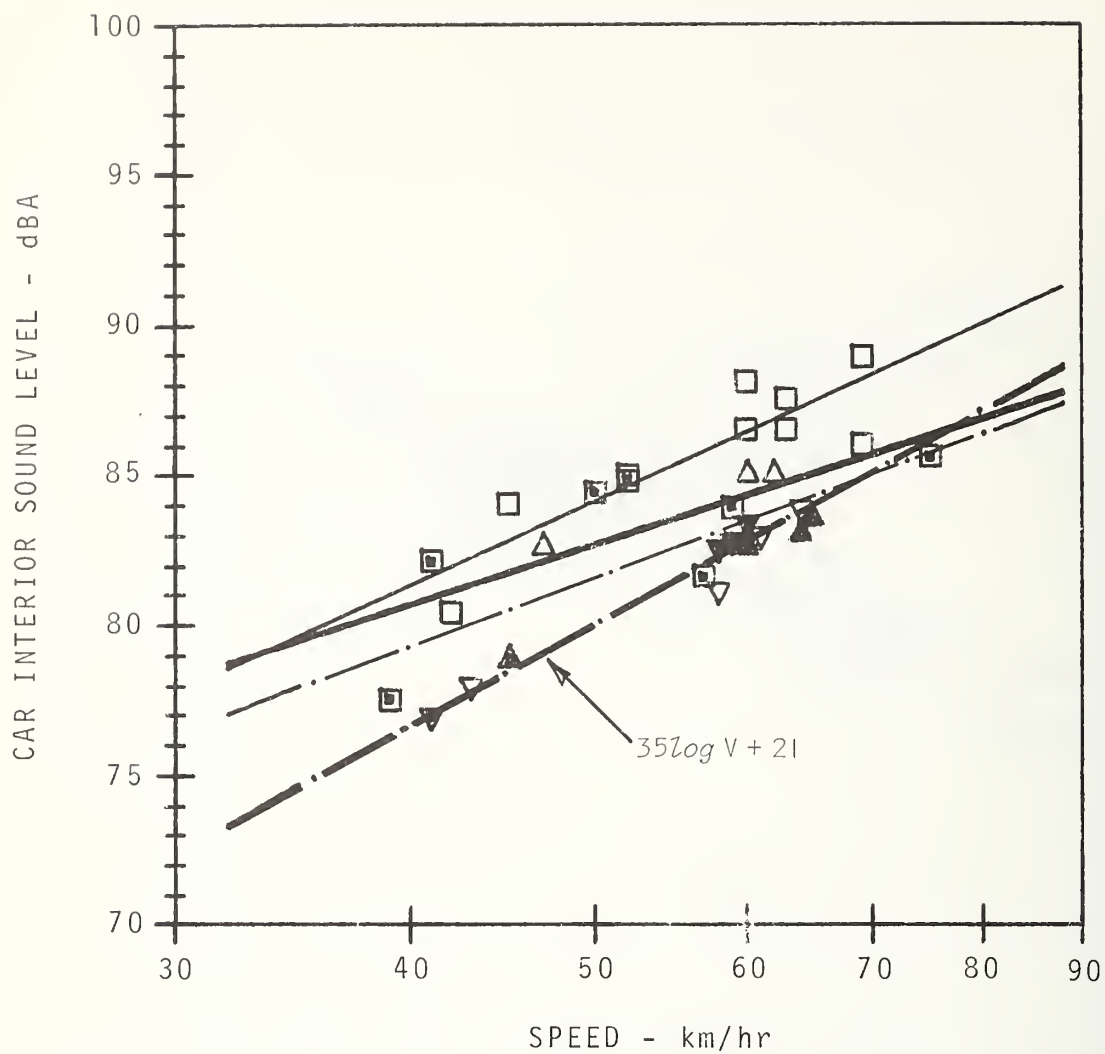
FIGURE 4-16. CAR INTERIOR SOUND LEVELS ON THE SUBWAY TEST TRACK, TANGENT WELDED RAILS

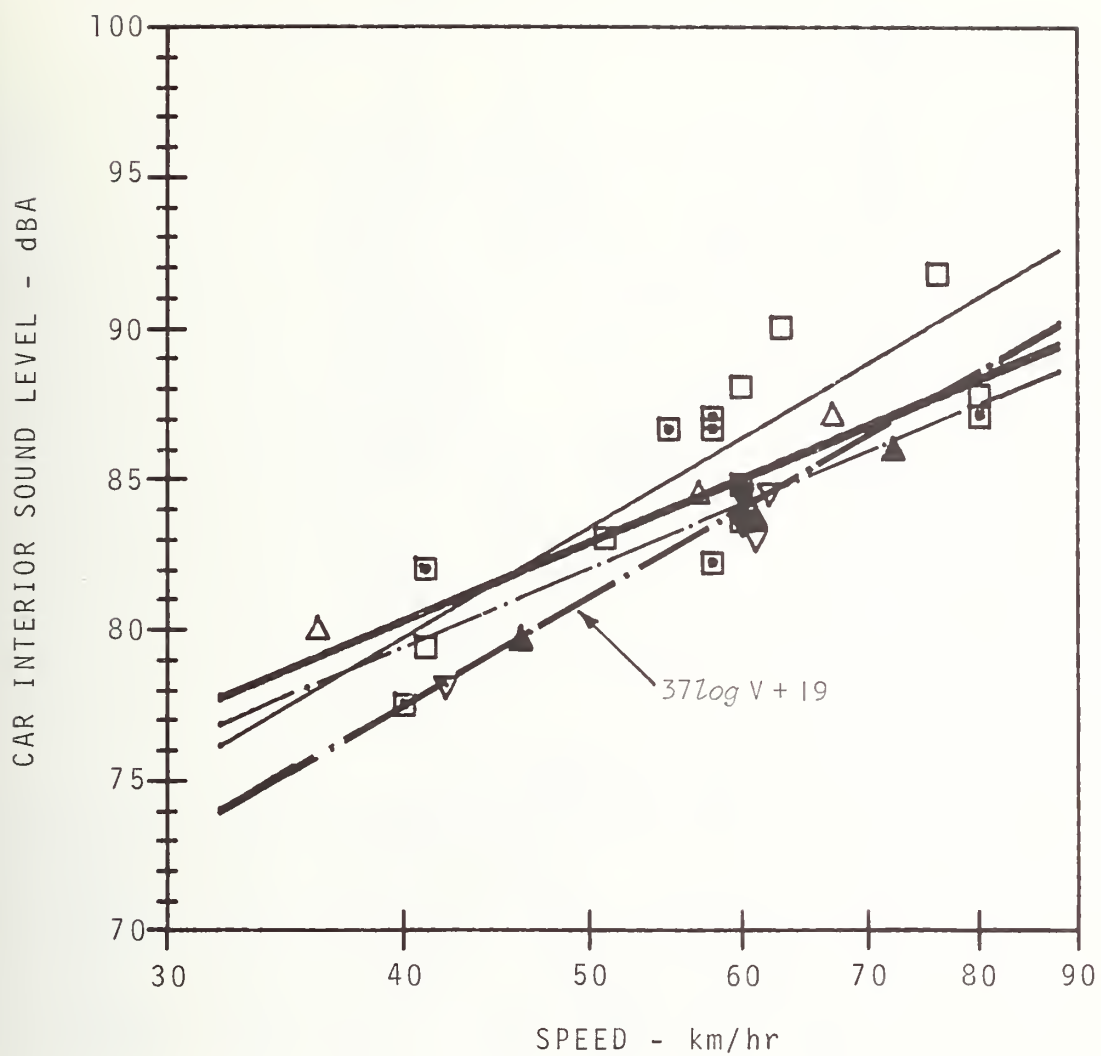
FIGURE 4-17. CAR INTERIOR SOUND LEVELS ON SUBWAY TEST TRACK, TANGENT JOINTED RAILS

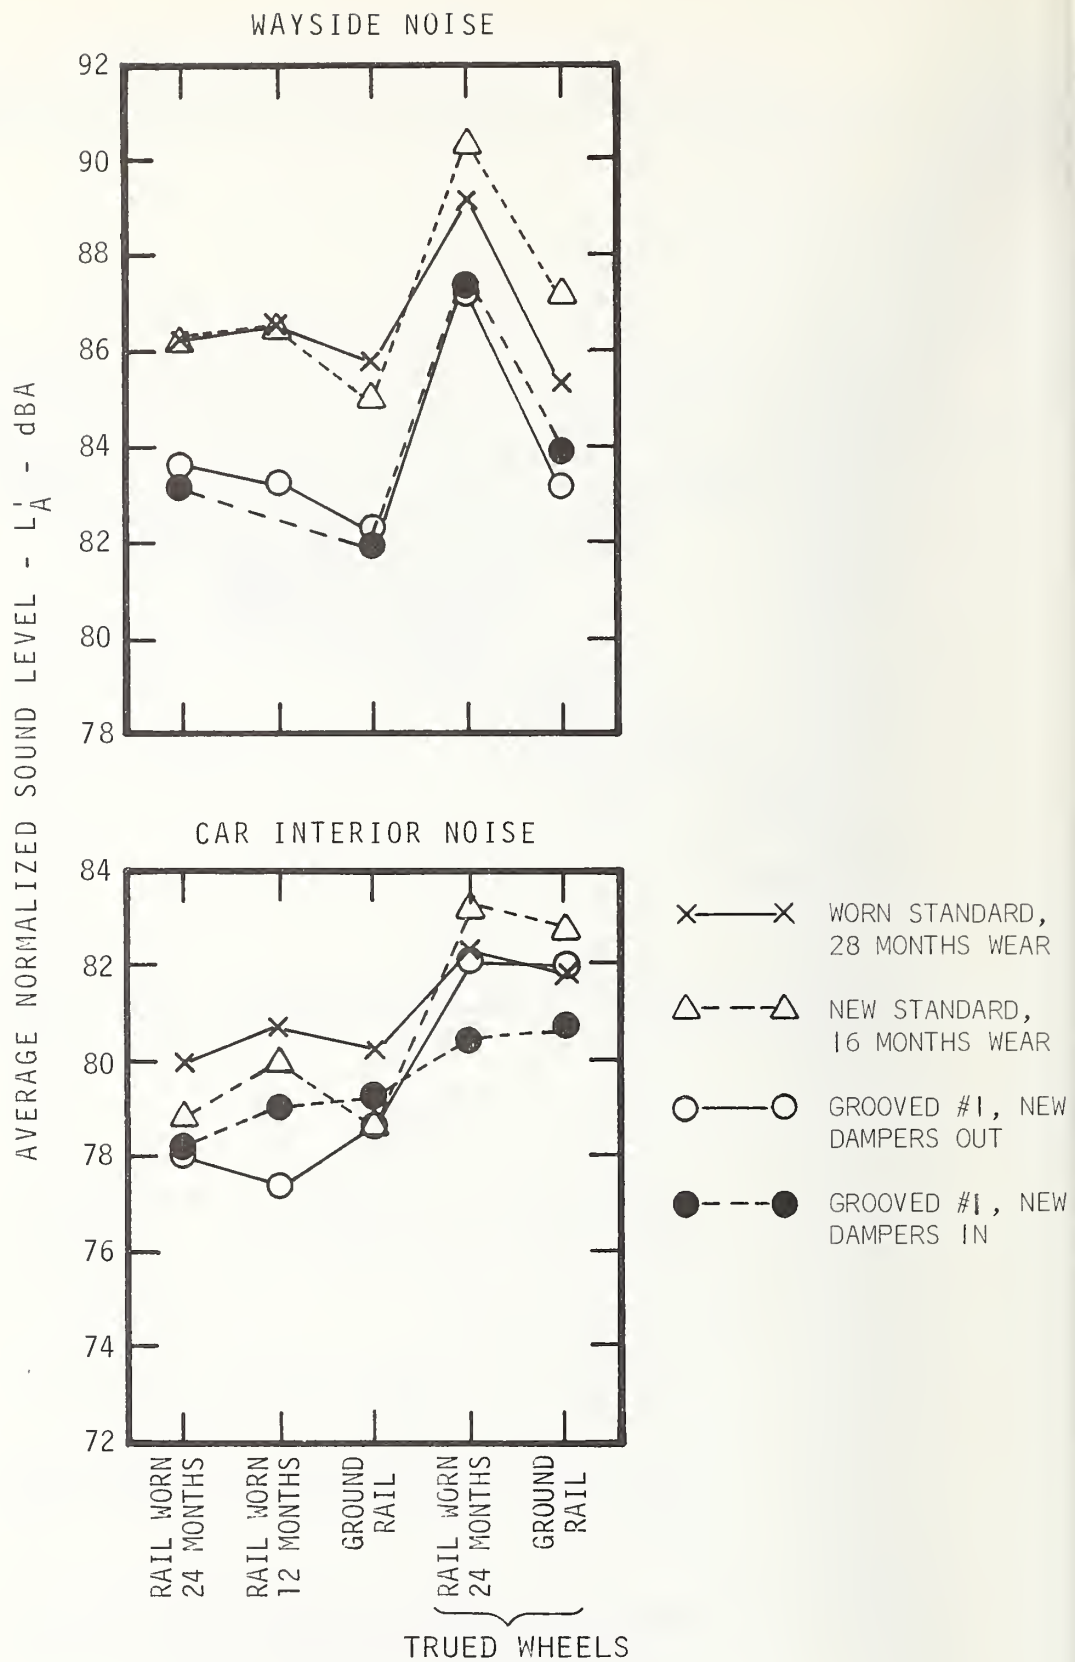
FIGURE 4-18. AVERAGE NOISE LEVELS AT TW TEST TRACK FOR VARIOUS WHEELS AND RAIL CONDITIONS

Figures 4-18, 4-19, 4-20 and 4-21 present data showing the average noise levels for various test conditions on the TW, TJ, SUB and TURN test tracks. The charts include data for the standard and ring-damped wheels.

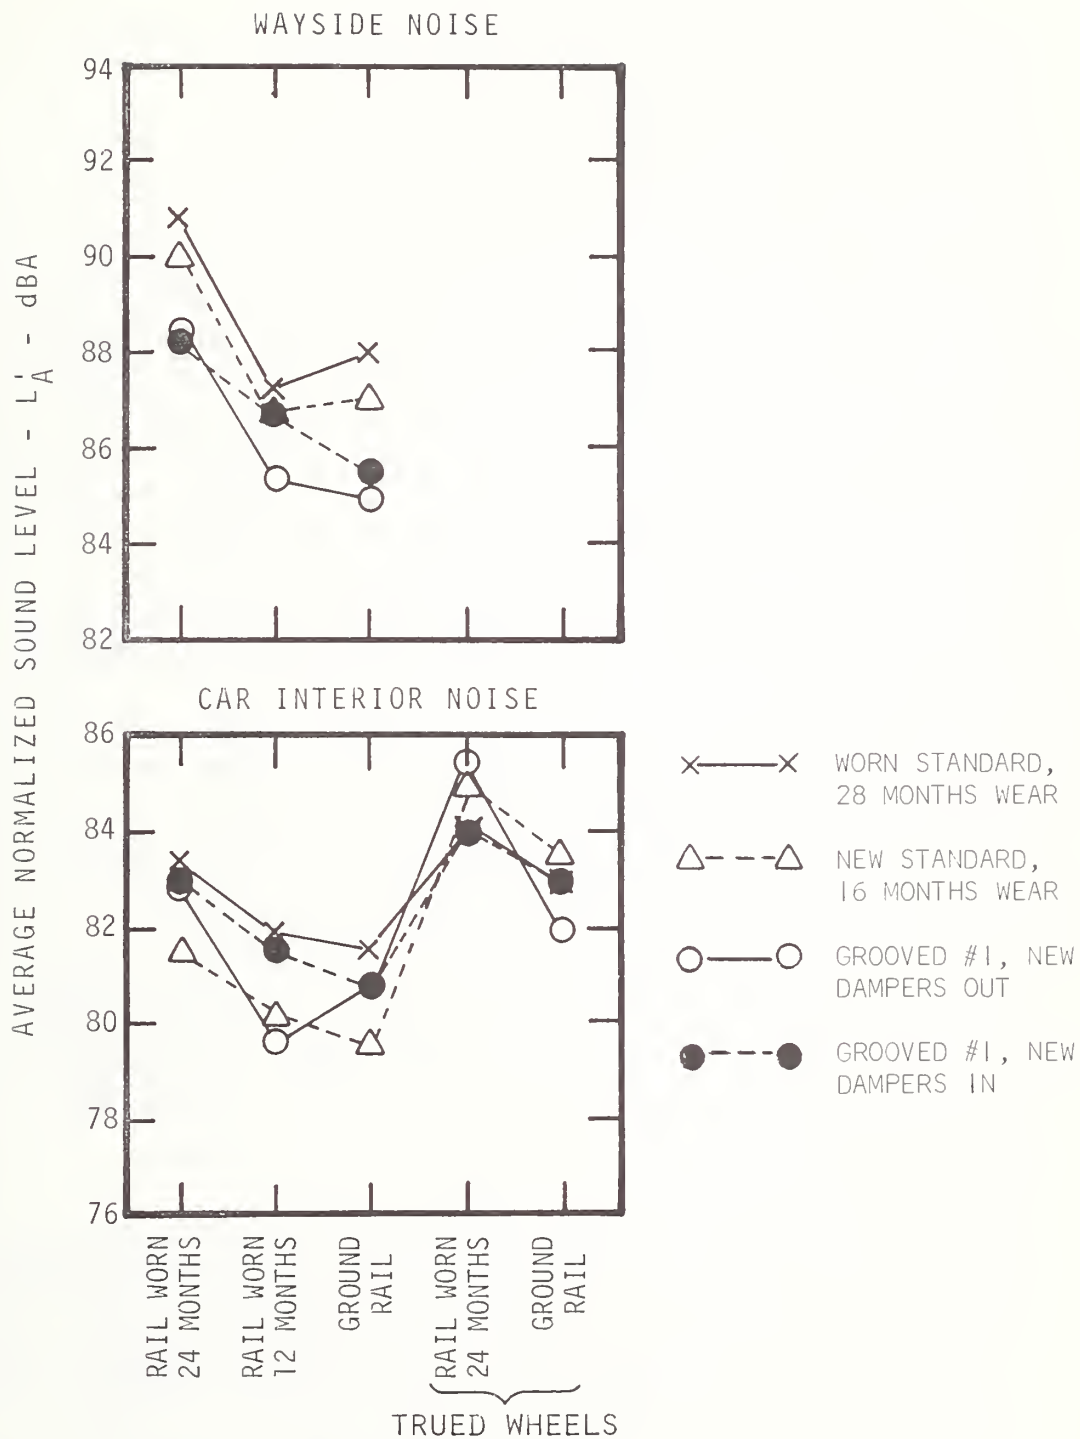
FIGURE 4-19. AVERAGE NOISE LEVELS AT TJ TEST TRACK FOR VARIOUS WHEELS AND RAIL CONDITIONS

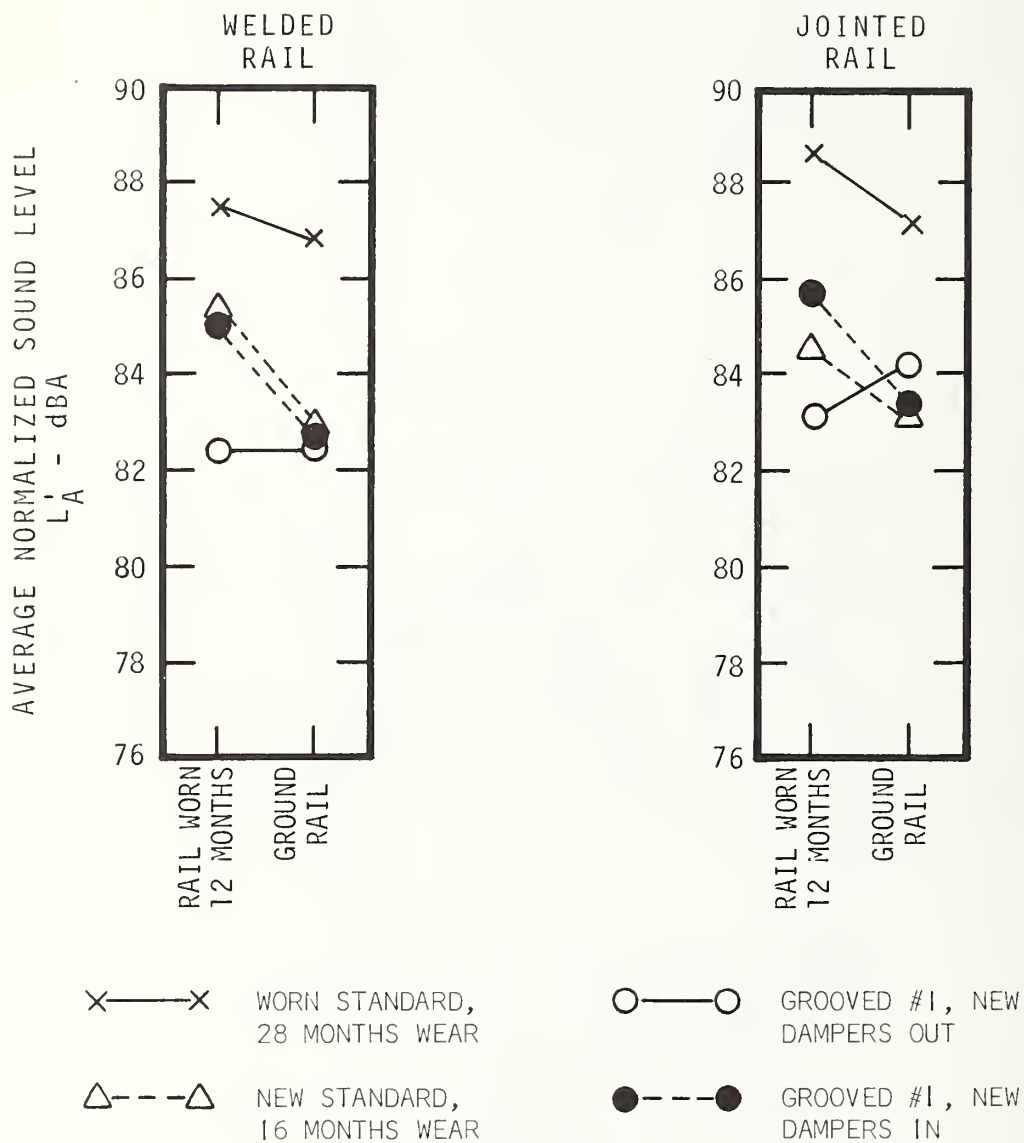
FIGURE 4-20 AVERAGE CAR INTERIOR NOISE LEVELS AT SUBWAY TEST TRACKS FOR VARIOUS WHEELS AND RAIL CONDITIONS

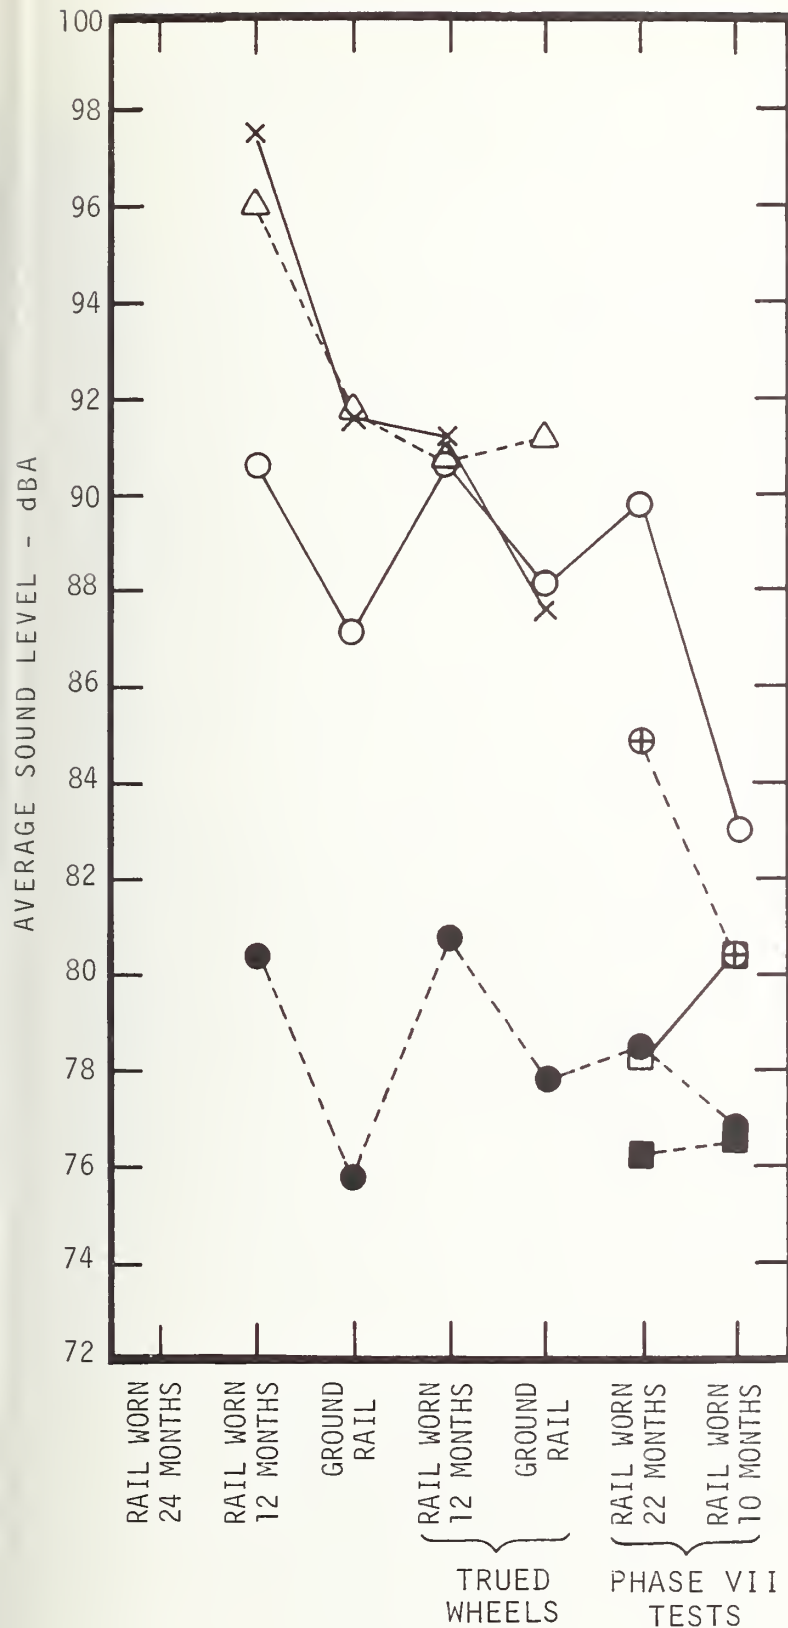
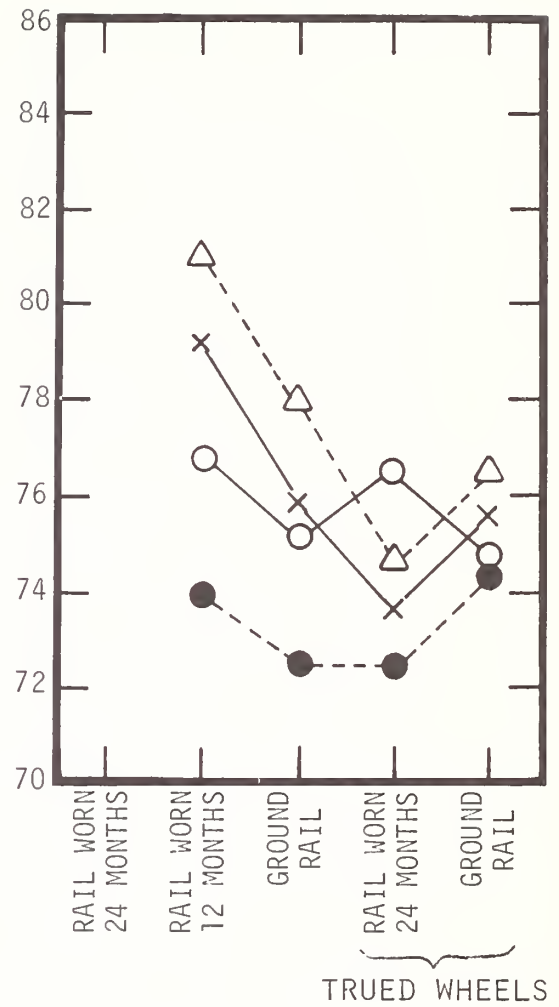
FIGURE 4-21. AVERAGE NOISE LEVELS AT TURN TEST TRACK FOR VARIOUS WHEELS AND RAIL CONDITIONS
